Bantry Bay Oil Terminal Fire

Bantry Bay and Whiddy Island SW Ireland

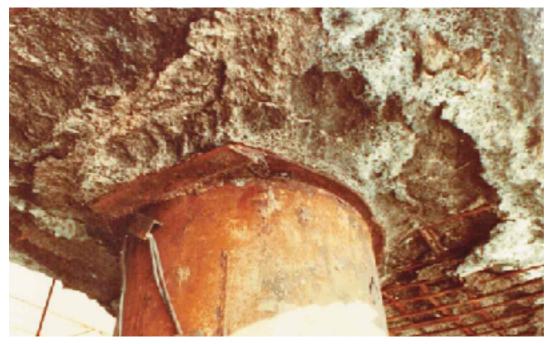
Damaged Underside of Jetty

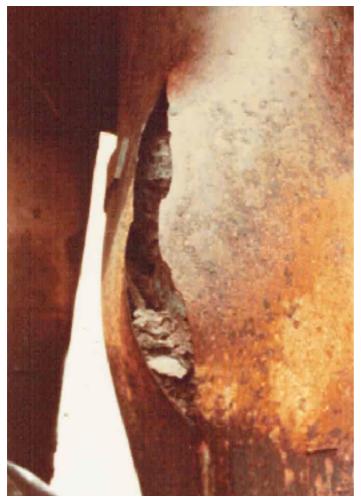
The steel cased piles were 40" diameter x 5/8" grade ASTM A36 or equivalent. They were filled with concrete but the excess moisture present during construction would have been trapped inside and become steam when they were exposed to the heat of the fire for several hours. As a result, some of them burst and the thickness reduced to approximately 1/8".

Burst Pile

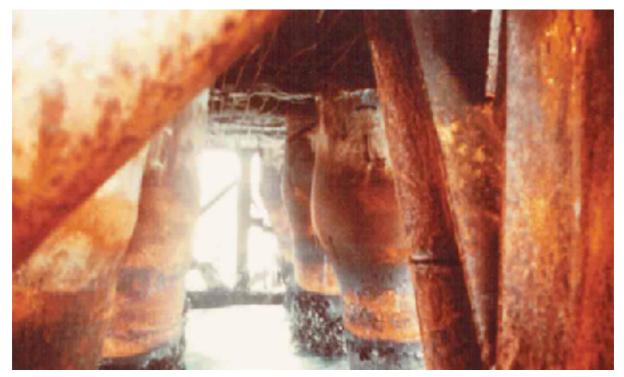
Burst Piles

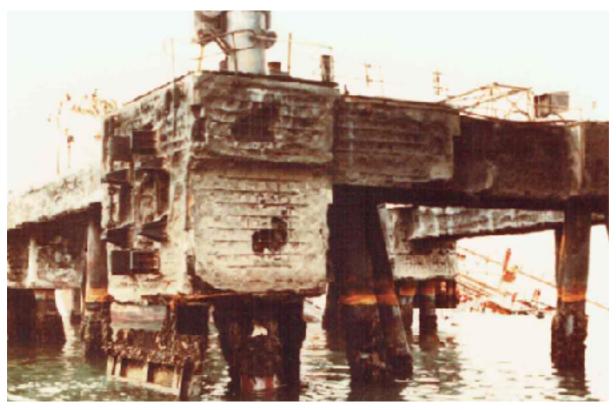
When concrete is subjected to intense heat, it spalls off the surface as the aggregate expands and the cement is weakened. The concrete changes colour with a similar effect to that to that when tempering steel. Concrete exposed to temperatures above approximately 300 °C tends to turn pink. Over approximately 600 °C it turns light grey, and over approximately 1000 °C it turns yellow-brown.

Damaged Concrete

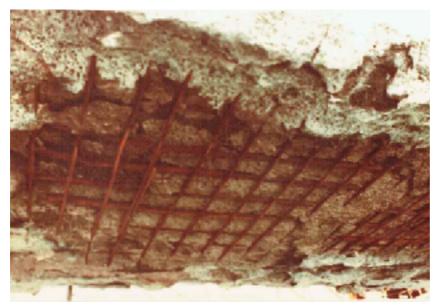
Damaged Concrete showing Reinforcement

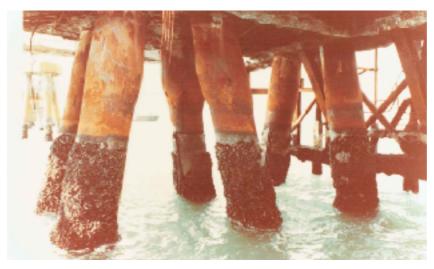
Damaged Piles

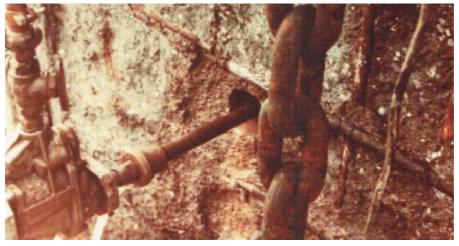
A programme of core drilling was established to obtain test samples to check the extent of damage to the concrete beyond the remaining surface. I recall that the pundit, a device to check the velocity of concrete across the diameter of a core sample, was used (possibly for the first time).

Core Drilling Tony Barber June 2020
